MINISTRY OF SUPPLY

AEROPLANE AND ARMAMENT EXPERIMENTAL ESTABLISHMENT

METEOR MR. 3 WF. 716 (DERGENT 8)

RADIO ACCEPTANCE TRIALS

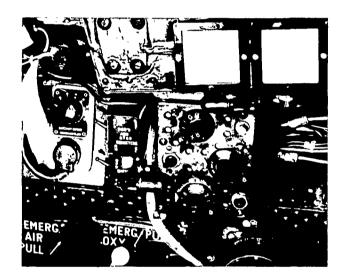
F1G.2.;

- 3.1.6 The Control Unit Type 909 was fitted on the starboard side of the pilot's cockpit (Fig. 2). The position was satisfactory for operation and for maintenance.
